IL&FS TAMILNADU POWER PLANT SITE VISIT

In order to investigate the current status of the plant and area around it, CAG's team working on EIA process with specific focus on thermal power plants went on a field visit to Kothattai village on March 15, 2018. Along with two activists Mr. Kalaiselvan and Mr. Nagalingam, the team interacted with some of the villagers and tried to collect enough information for the investigation.

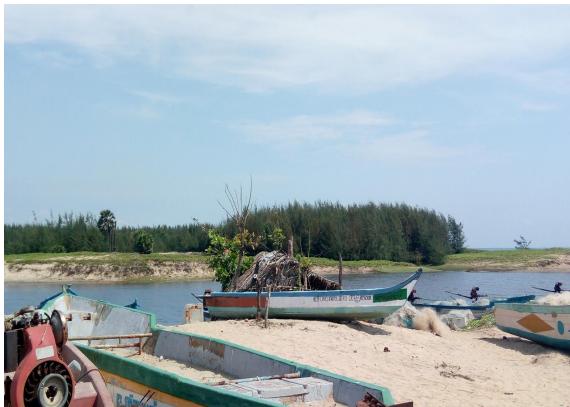
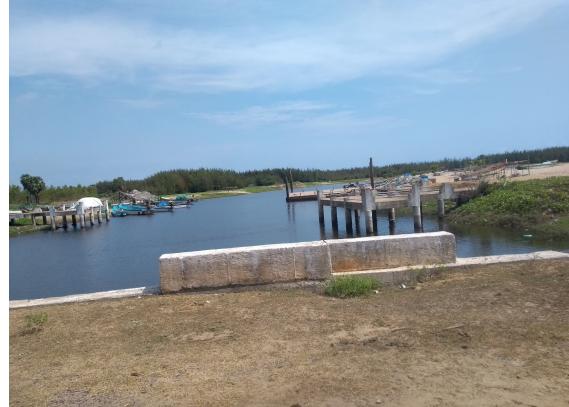
The team entered Pudhukupam where the IL&FS power plant is located. The team noticed some changes made to the natural water course. It has been widened to a man-made canal, presumably created by IL&FS Plant. Currently, around 90 local fishermen were making use of the widened canal, facilitated by temporary crane for pick-up of boat from seashore and leaving it on to the canal.

(Image: Boats parking inside the stream)

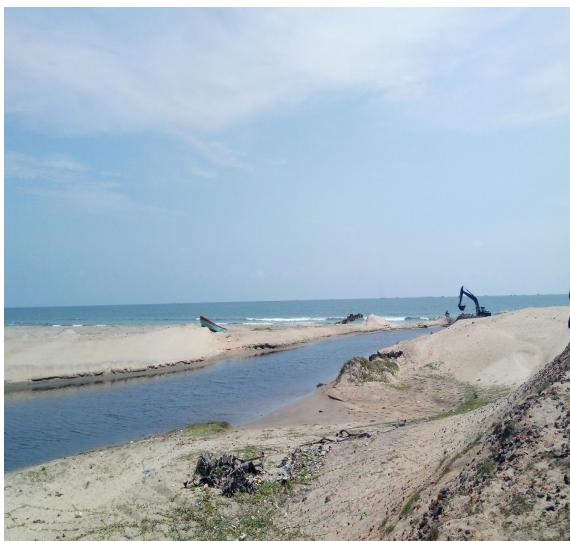
(Image: Mouth of the stream)

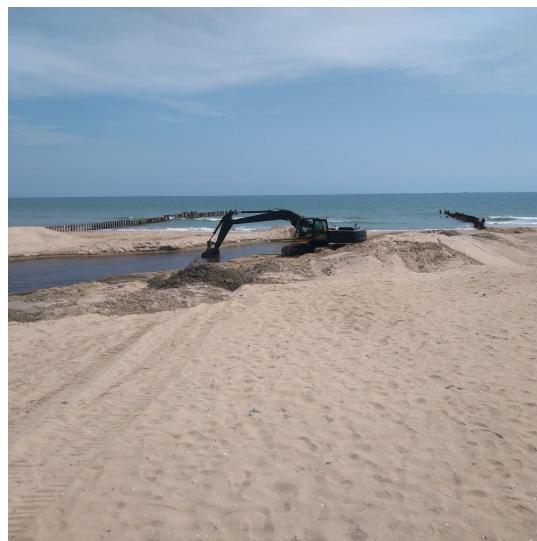
(Image: widening of stream mouth)

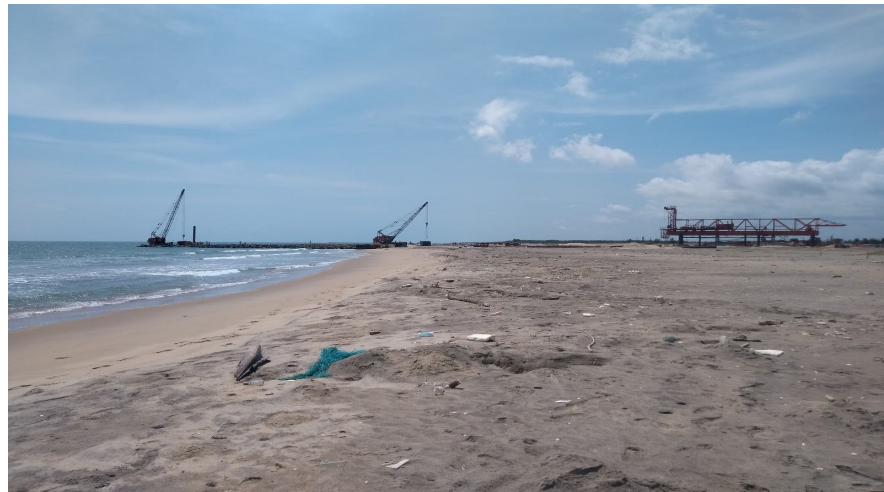
Here, we also observed trucks carrying rock boulders for the construction of the port and the construction activity was already in progress with the help of cranes and construction of conveyor system was also in process.

(Image: construction of the port)

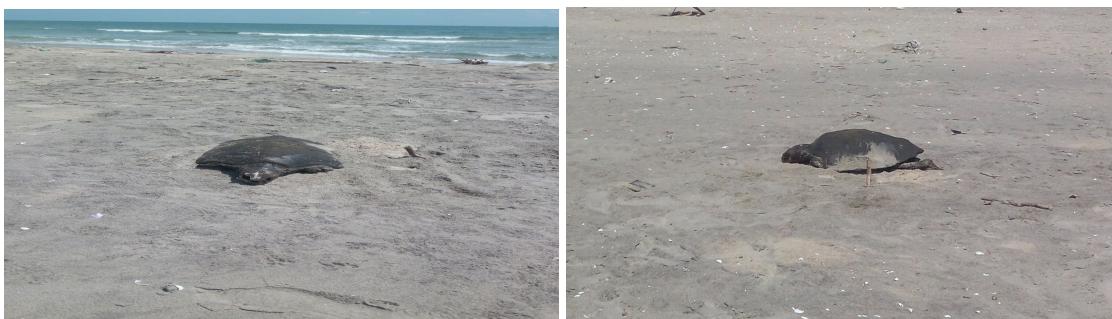
We could also observe dead and decaying Olive Ridley turtles on the shore, which indicates that this location may be part of “the migratory route” for Olive Ridley. In the EIA report there is no mention of olive ridley which clearly shows that project proponent completely ignored the fact of olive ridley’s migratory route.

(Image: Dead and decayed olive ridley turtle)

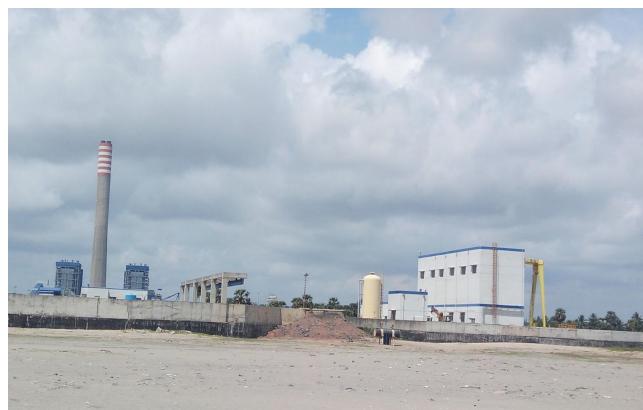
We could see the desalination plant of IL&FS power plant and its pressure discharge point.

(Image: Desalination plant)

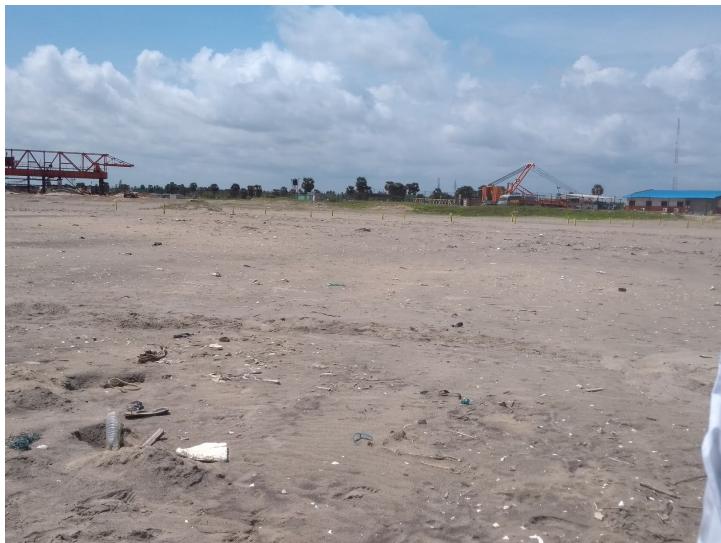
Pipelines were laid underground for water intake and outlet for the plant. The underground area was marked with small yellow pillars for indication of pipeline.

(Image: Small yellow pillars indicates the Pipeline of plant for intake and outlet)

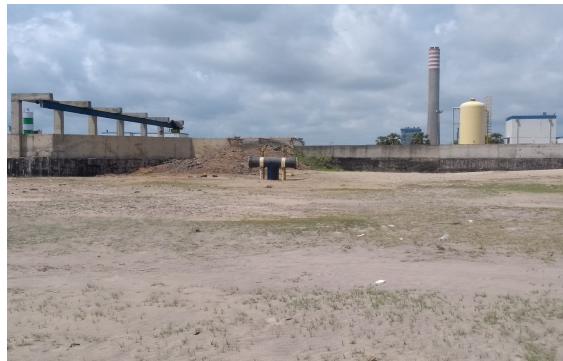
The intake valve structure and the overflow outlet structure were outside the boundary of the plant.

(Image: Intake valve structure)

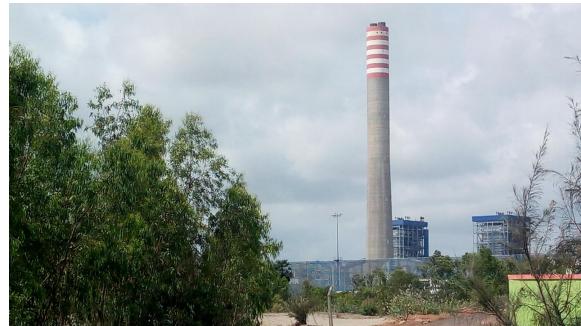
According to the [daily generation report](#) by National power portal shows generation of 27.37MU (1140MW) for 15/3/2018. But during our visit on the same day around 10am to 2am, we couldn't notice any plume at the stack.

(Image: IL&FS power plant)

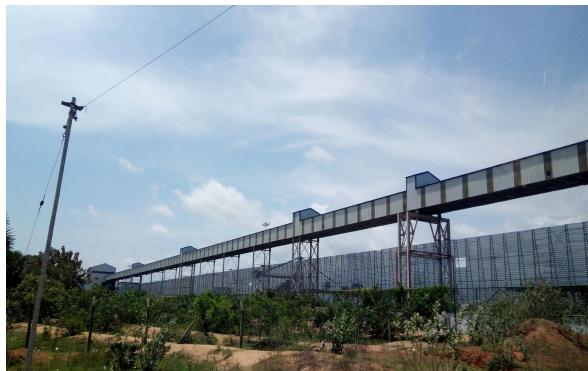
Outside the boundary, we could see the coal storage area with screens and conveyor belt system, that which was partially covered. According to EC conditions, project proponent should use shelterbelts/greenbelts/trees which will act as buffer against strong wind to avoid ground level pollution.

(Image: Coal conveyor belt)

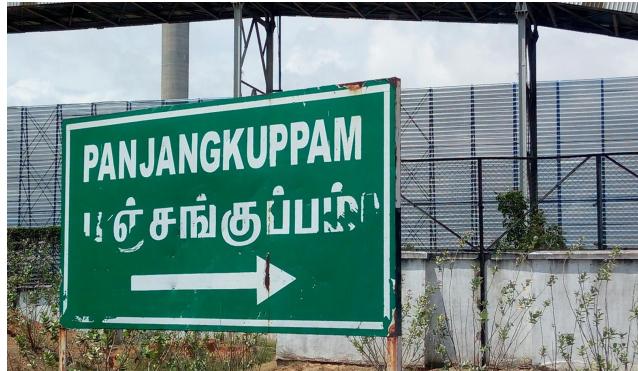
(Image: Screen at coal dumping yard)

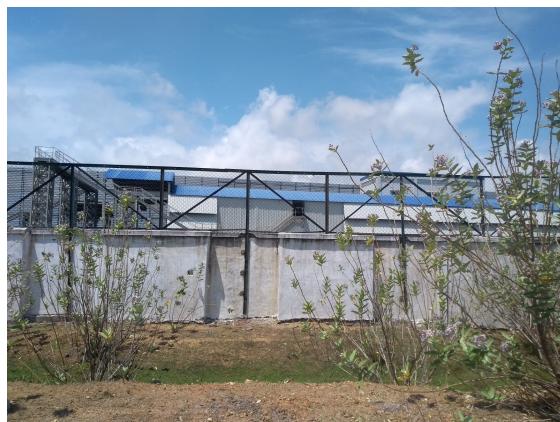
There was a wagon unloading station. The plant currently receives coal from Karaikal port through train. The power transmission area is located inside the plant.

(Image: wagon unloading center)

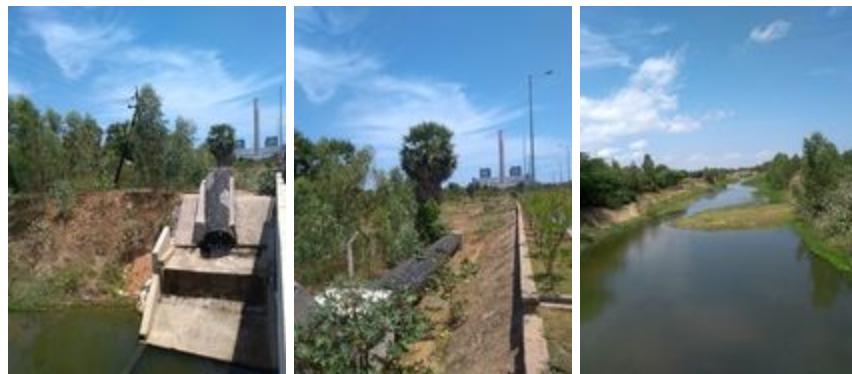
The plant also had an “Outlet drainage pipe” originating from Plant premises and letting it to Buckingham Canal. Though it was claimed to be a storm water drain, the local people had complained that the water exiting that drain inflicts rashes on the skin on few villagers after washing hands from the canal in the downstream side. They also reported that few goats are dead after consuming the water.

(Image: stormwater drain)

Outlet drainage pipe	<ul style="list-style-type: none"> ❖ We could notice the outfall of outlet drainage pipe in to the Buckingham canal. ❖ This pipeline discharge stormwater into the canal from the plant.

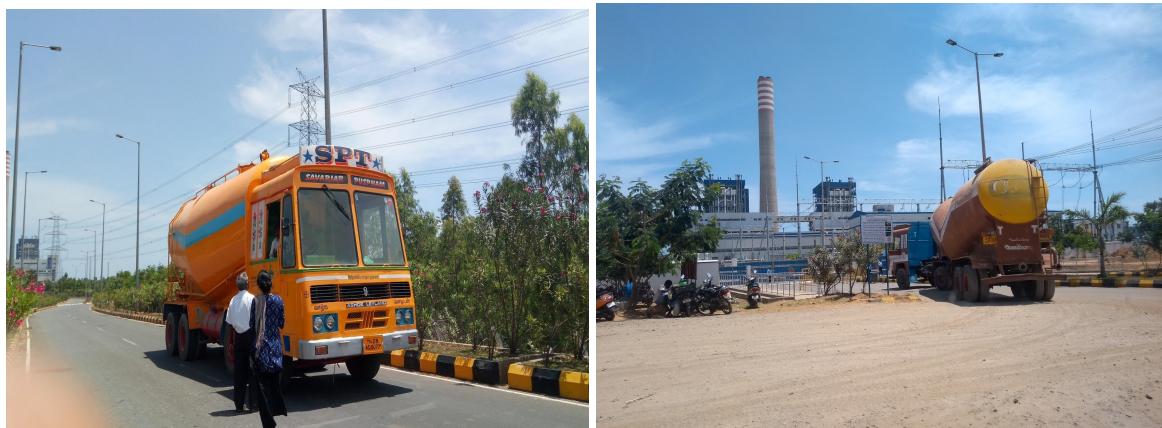
At the entrance of the plant we could see trucks waiting to enter the plant for fly ash collection. And we spoke with the driver to get some information regarding disposal of fly ash. As per the driver he collects fly ash from silo and direct it to the nearest cement industries.

(Image: Trucks carrying fly ash)

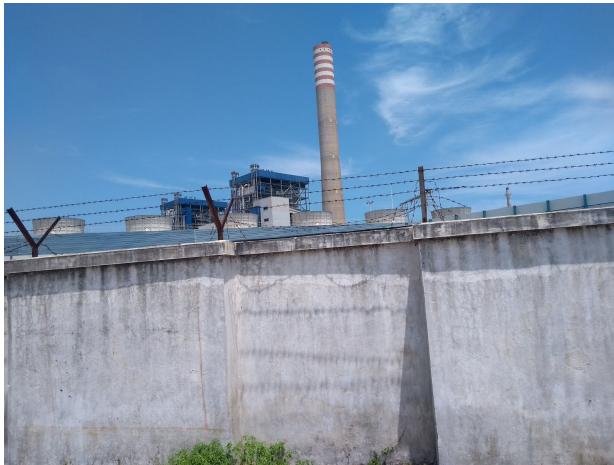
(Image: Top of the cooling tower)

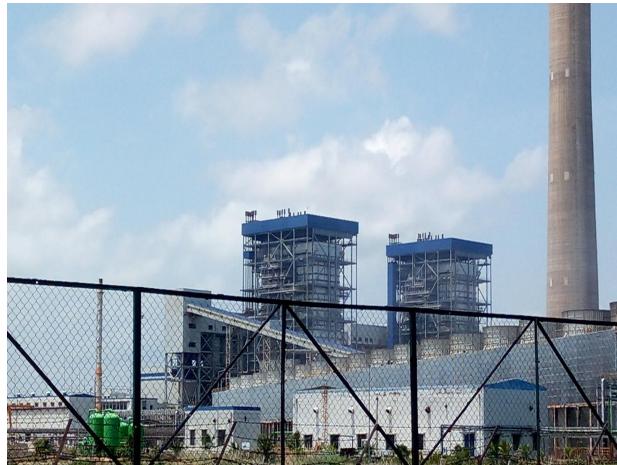
(Image: Chemical storage tank (small green tanks))

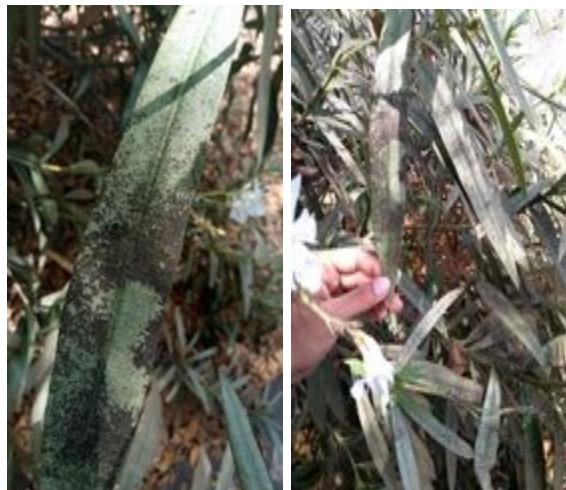
During a conversation with the local farmers, they showed their concern regarding the deposition of ash and coal particulate matter on plant leaves, though very few traces have been found. The farmers claimed that the unobservability was due to the rain that happened two days back.

(Image: Ash deposition on leaves)

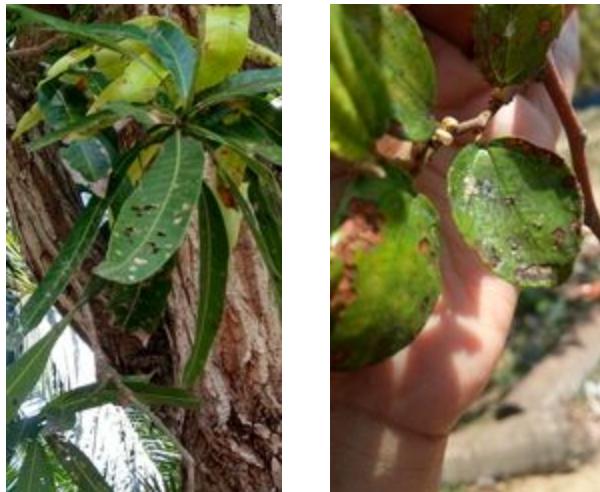
A farmer stated that the leaves of the mango tree were getting burnt and the yield from the tree has also reduced by more than half. Although we don't have enough evidence regarding the same.

(Image: Burning mark on leaves)

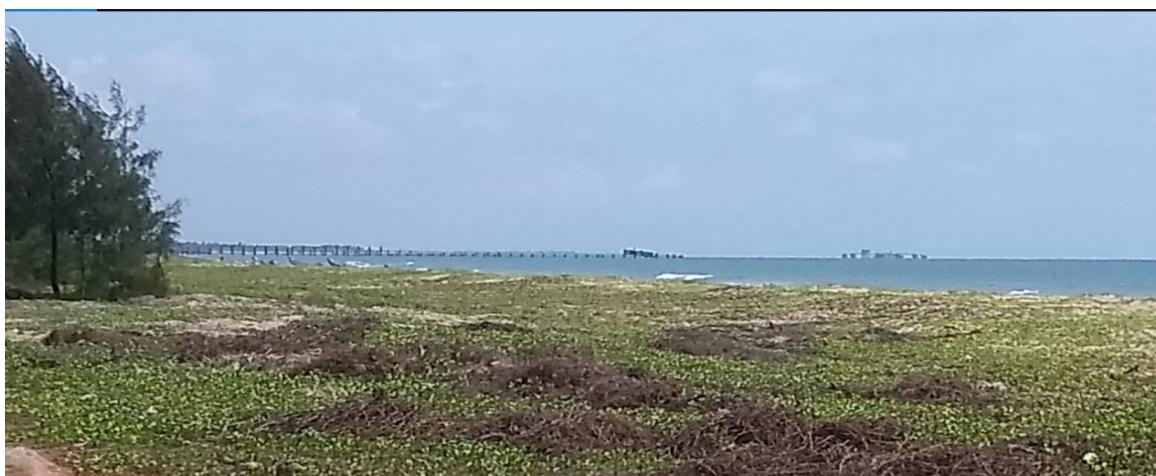
The team had a look on the abandoned port of [Nagarjuna oil refinery](#). The refinery was said to be destroyed by the Thane cyclone. From a few kilometers distance into the sea, the Island Jetty for boat landing is provided for [Chemplast sanmar](#) and [Marine Terminal Facility \(MTF\)](#) for import of Vinyl Chloride monomer is present there. According to the local activists, [Allied Silica Ltd](#) is also using the same MTF for unloading and loading of chemicals.

(Image: Jetty like structure of chemplast sanmar and Allied silica ltd)

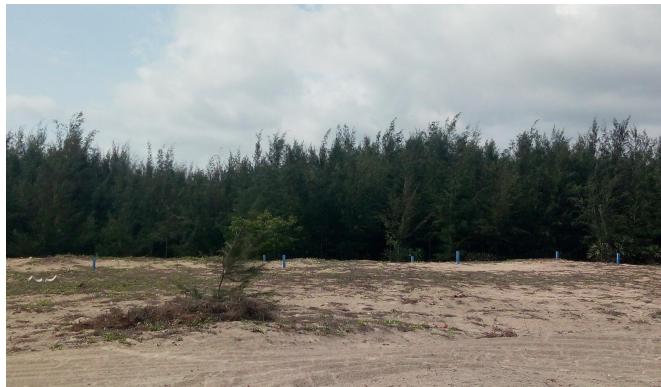
In Badapallam, we noticed the underground effluent pipeline(small blue pillars) from the SIMA project, exiting into the sea. The SIMA project plant has been closed due to the pressure from the local community .

(Image: Small blue pillars represents the underground effluent pipeline for SIMA project)
